SPOTLIGHT ON LOCAL STREAMS:

Summary Report on Lodge Creek, Moores Creek, Schenks Branch and Meadow Creek

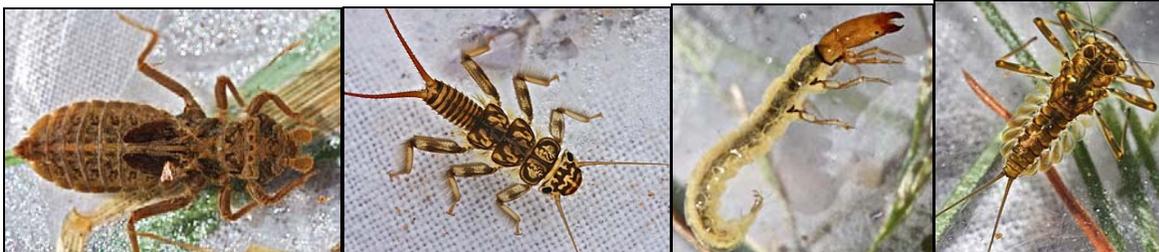
The basis of a stream's food chain is found in the community of the aquatic organisms that live at the bottom of the stream, known as benthic (or bottom-dwelling) macroinvertebrates (organisms without backbones that can be seen with the naked eye). These bugs are important because they are a key food source for other organisms, they play an important role in the cycling of nutrients, and they are good indicators of pollutants. The aquatic life water quality standard states that all state waters should support a healthy and diverse community of invertebrates and fish. Based on VADEQ's and StreamWatch biological monitoring results, it was concluded that segments of Lodge Creek, Moores Creek, Schenks Branch and Meadow Creek were not meeting this standard. Here are a few examples of benthic macroinvertebrates (all images courtesy of Bob Hendricks).

From Left to Right: Dragonfly larvae, Stonefly nymph, caddisfly larvae, flathead mayfly larvae.

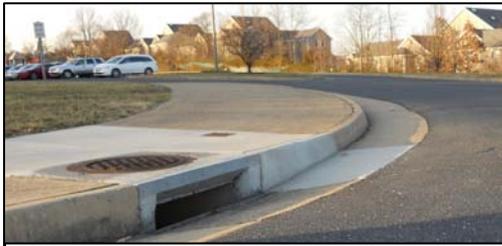
Stormwater conveyance in a parking lot. (Credit: VADEQ)

How does pavement hurt streams? Instead of naturally allowing rainwater to infiltrate into the soil, impervious surfaces quickly move it into conveyance structures, like storm drains or storm sewers, or directly into streams and rivers. This is known as **stormwater runoff** and impacts streams in a multitude of ways. Stormwater is a problem because it washes pollutants like **sediment** from construction sites, oil from vehicles, nutrients from fertilized yards, and bacteria from pet waste into streams and rivers. Also, stormwater increases the flow in streams after a precipitation event, which can result in scouring of sediment from exposed streambanks, and often adds to the problem.

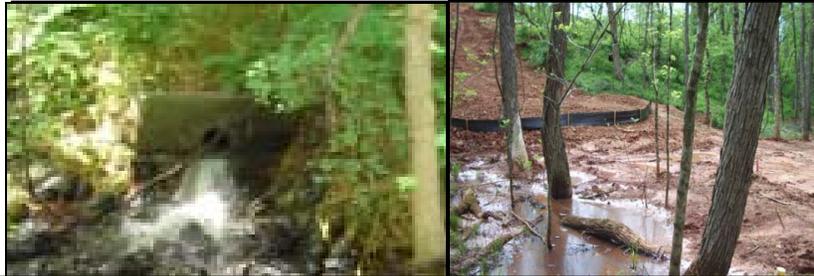
Point Source vs. Non-point Source (Credit: VADEQ – Jeffries and Harrigan)

***NONPOINT** Sources of pollution are those from diffuse areas with no single point of entry to a waterway (streets, sidewalks). **POINT** Sources of pollution are from a definitive point or outfall (a pipe from a factory).*

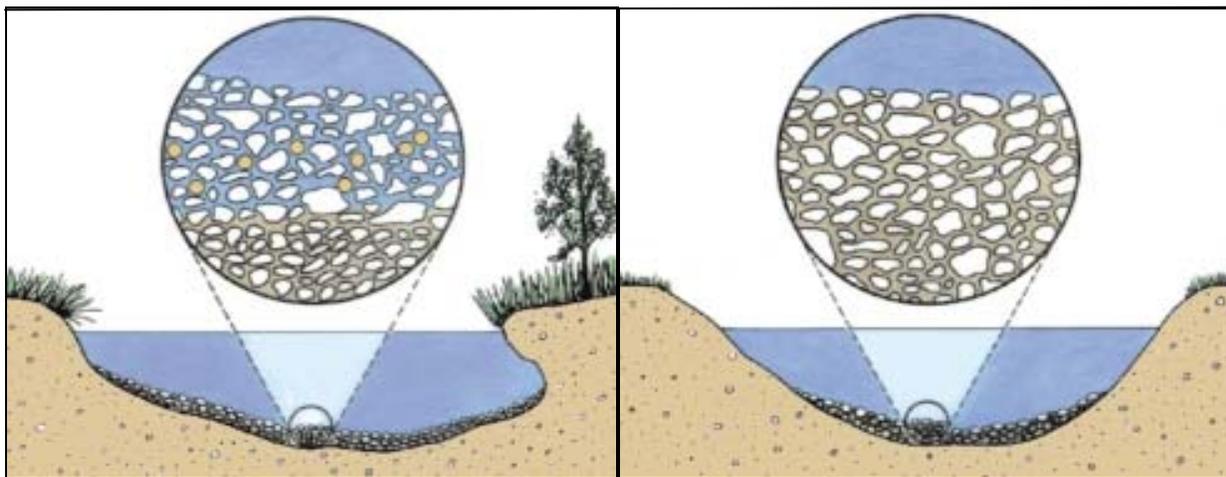
Why is too much sediment in a stream system a problem? Aquatic organisms need space in between rocks and gravels on the stream bottom in order to make their homes, move, and capture prey. With too much sediment, the niches in between the rocks are filled in, it's difficult to travel, and food sources are eliminated. Below is an illustration of a healthy stream bed versus one with extra sediment.

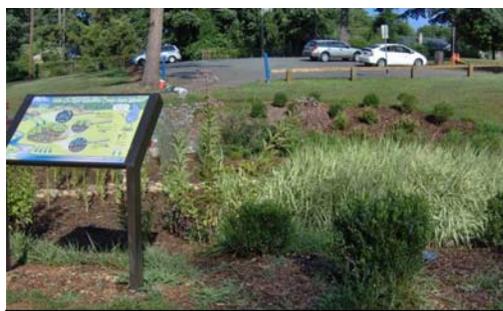
Greanleaf Park Rain Garden
(Credit: City of Charlottesville)

upgrade a Sanitary Sewer Interceptor along the stream; existing stormwater management programs in Albemarle County, the City of Charlottesville, the University of Virginia, and along VDOT properties; incorporation of urban infiltration practices, such as the **rain garden at Greanleaf Park** and retrofitting green roofs on existing municipal buildings, such as the Charlottesville City Hall and the Police Building. In addition, efforts will be made to learn from, and coordinate with, other existing TMDLs for bacteria and sediment in the Rivanna River Basin and the Moores Creek Bacteria TMDL Implementation Plan.
